Fort Leonard Wood – Building 2101

Interior Character-Defining Features, Inventory and Assessment

April 2014

Final report

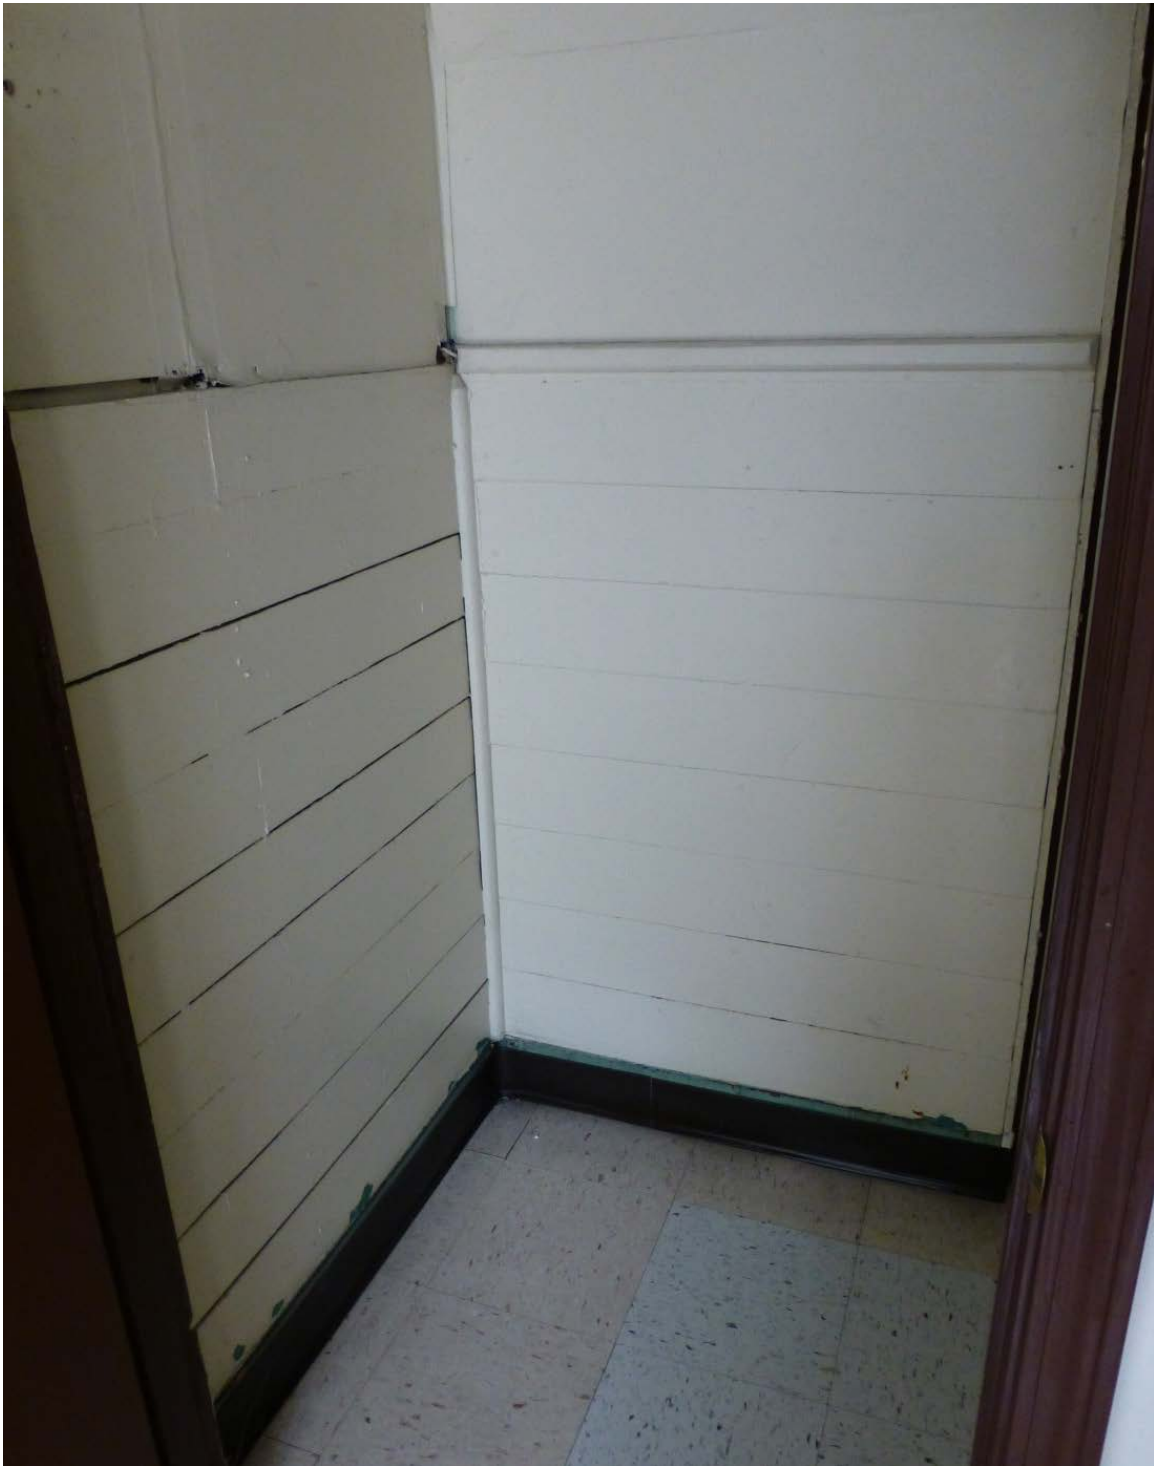
There are only a few spots where the original wall material is still extant, and they are all in the southeast quadrant of the building. There is a small hallway with the original wood wainscot and original wallboard above (Figure 11), a broom closet off that hallway with the original wood wainscot and original wallboard above (Figure 12 and Figure 13), and a large room with the original wood wainscot and original wallboard above

Figure 11. Southeast hallway with original wainscot and original wallboard above (ERDC-CERL, 2013).

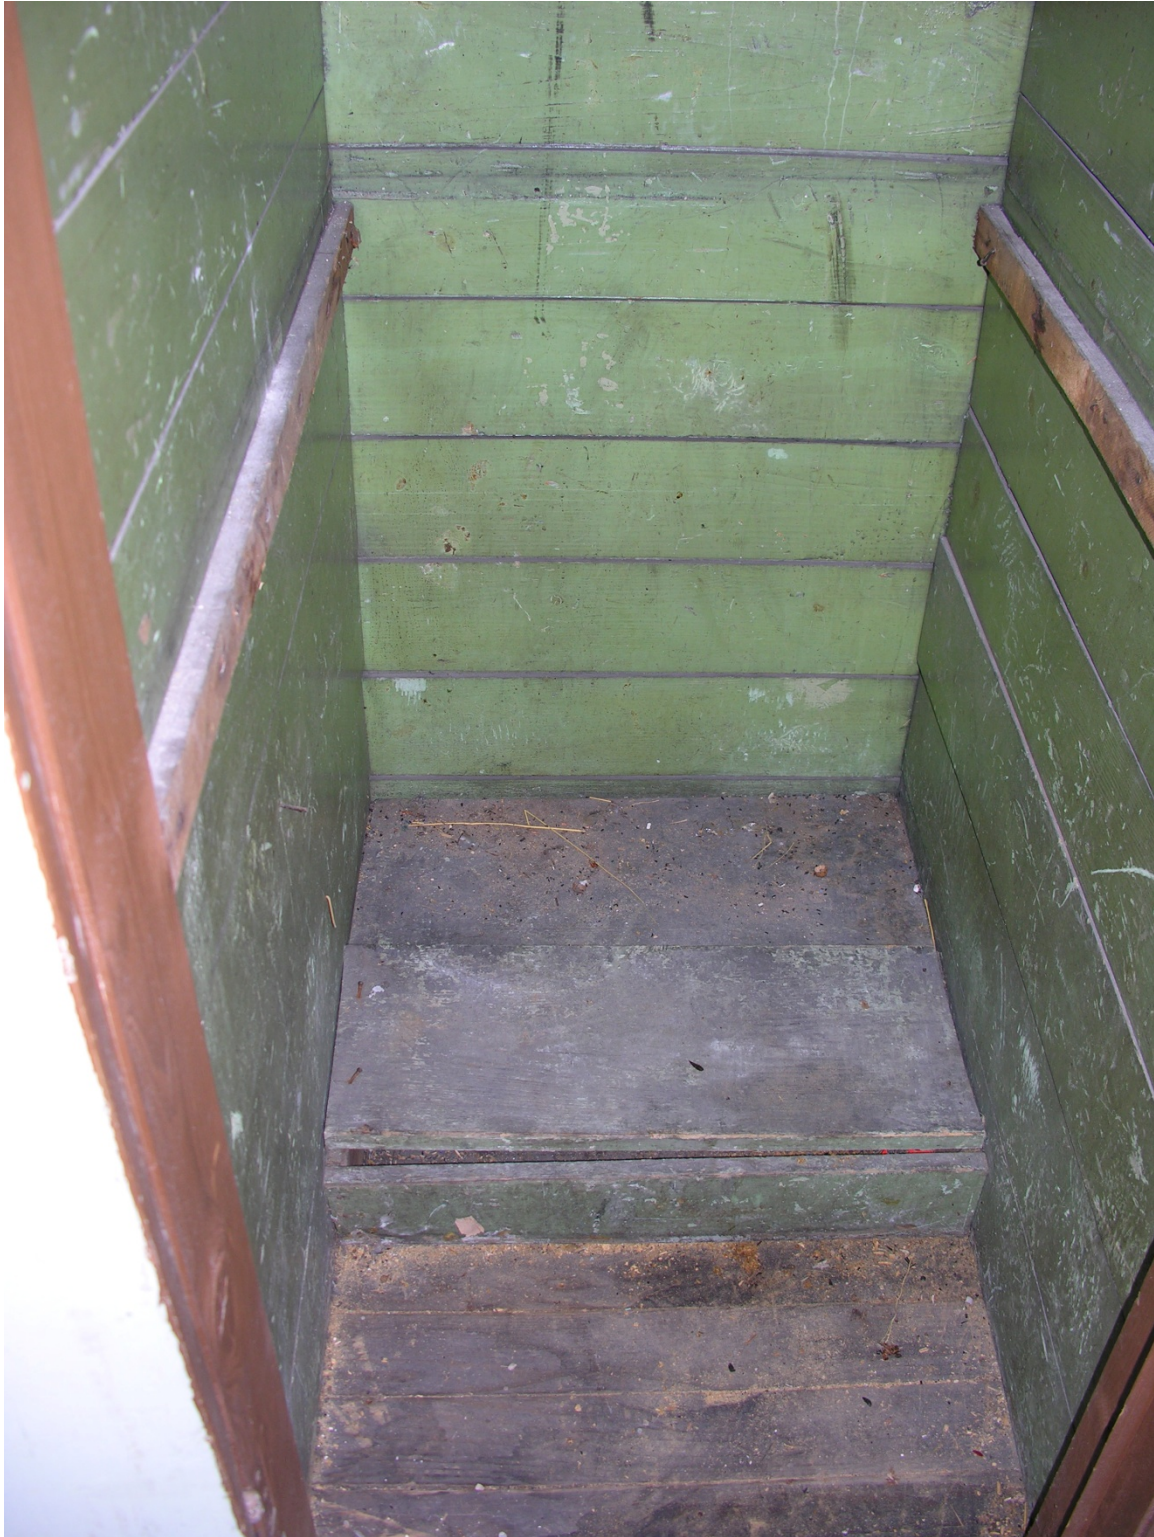
Figure 12. Closet off southeast hallway with original wood wainscot (FLW, 2014).

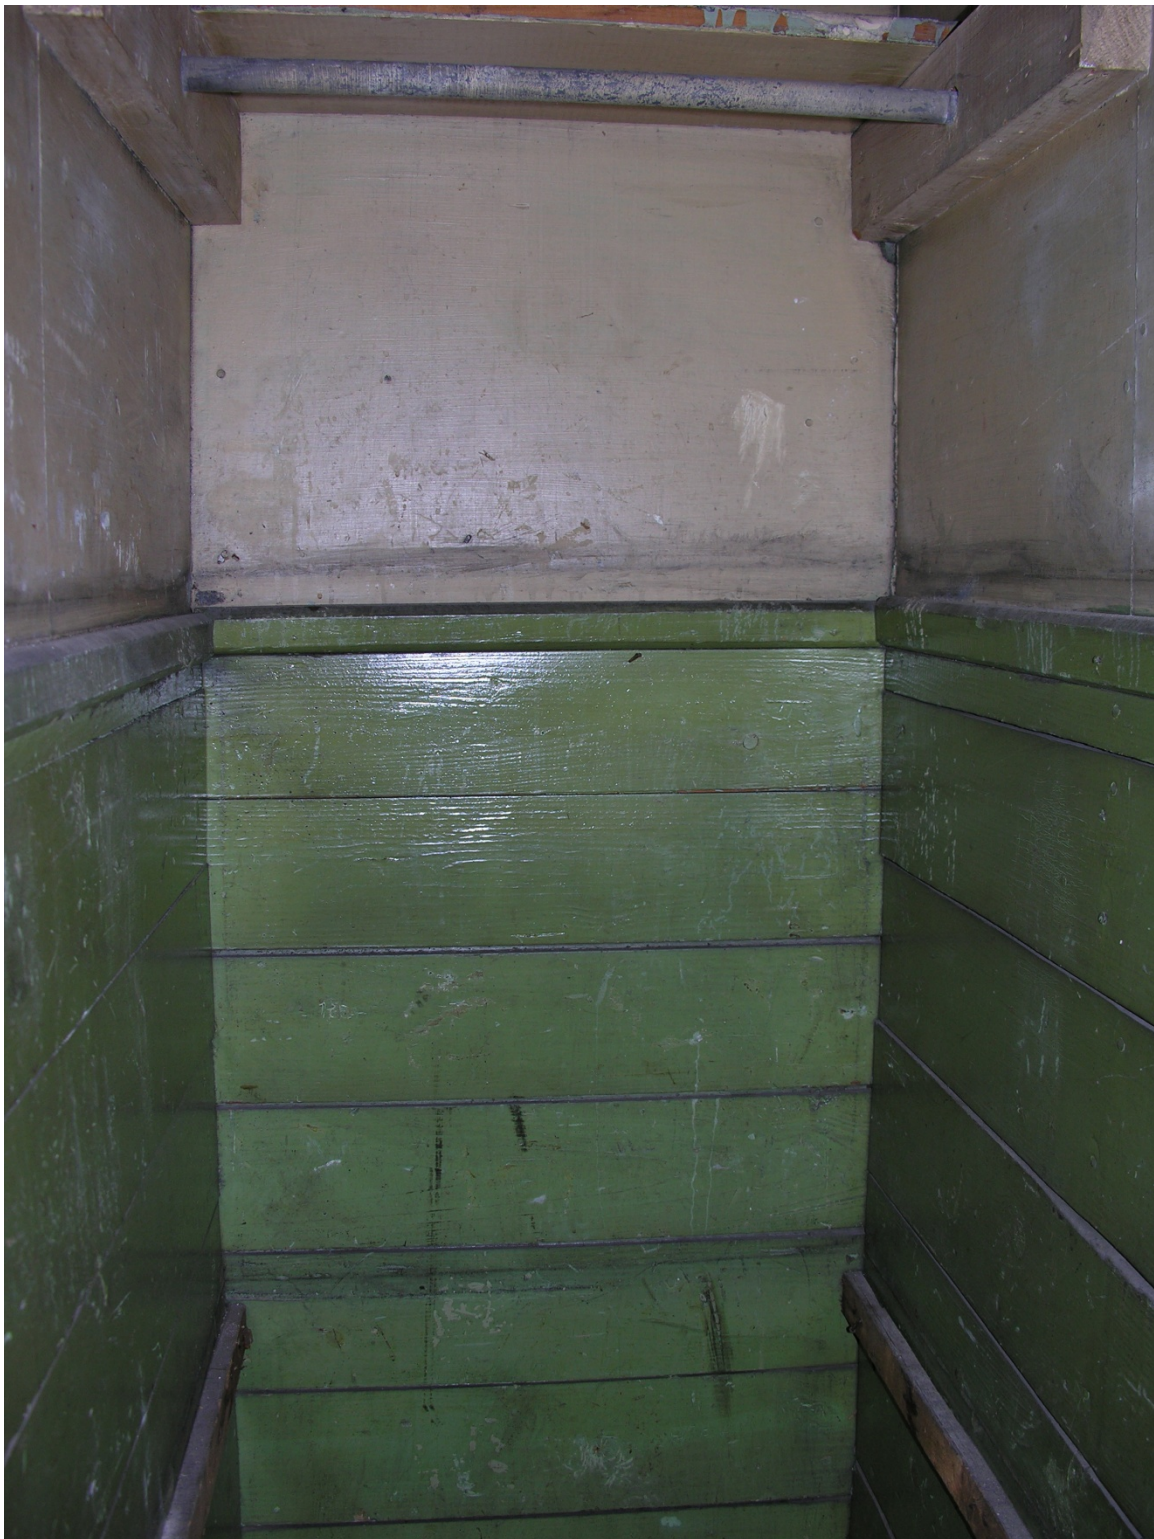
Figure 13. Closet off southeast hallway with original wainscot and original wallboard above (FLW, 2014).

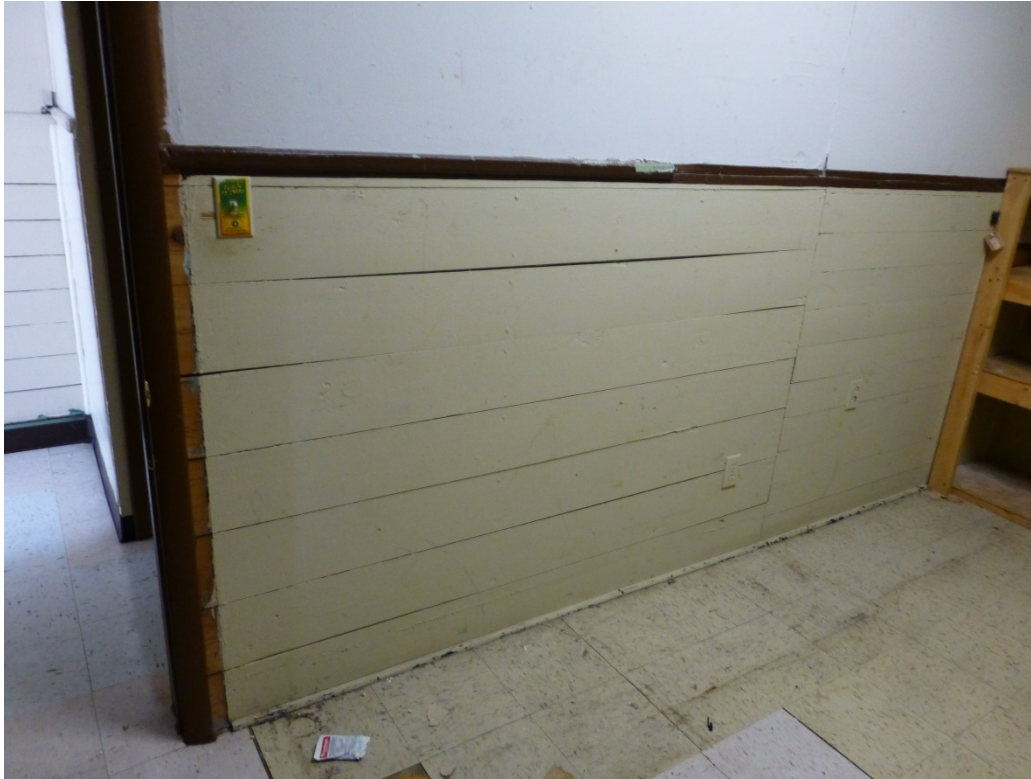
(Figure 14). In all three areas, the original wood trim transition between the wood wainscot and wallboard is still extant as well as the wood quarter-round detail in the corner of the wainscot (Figure 15). No other wall surfaces are original in the interior of the building. What is left of the wallboard, wood wainscot, and wood trim transition pieces are all character-defining features.

Figure 14. Original wood wainscot in large southeast room (ERDC-CERL, 2013).

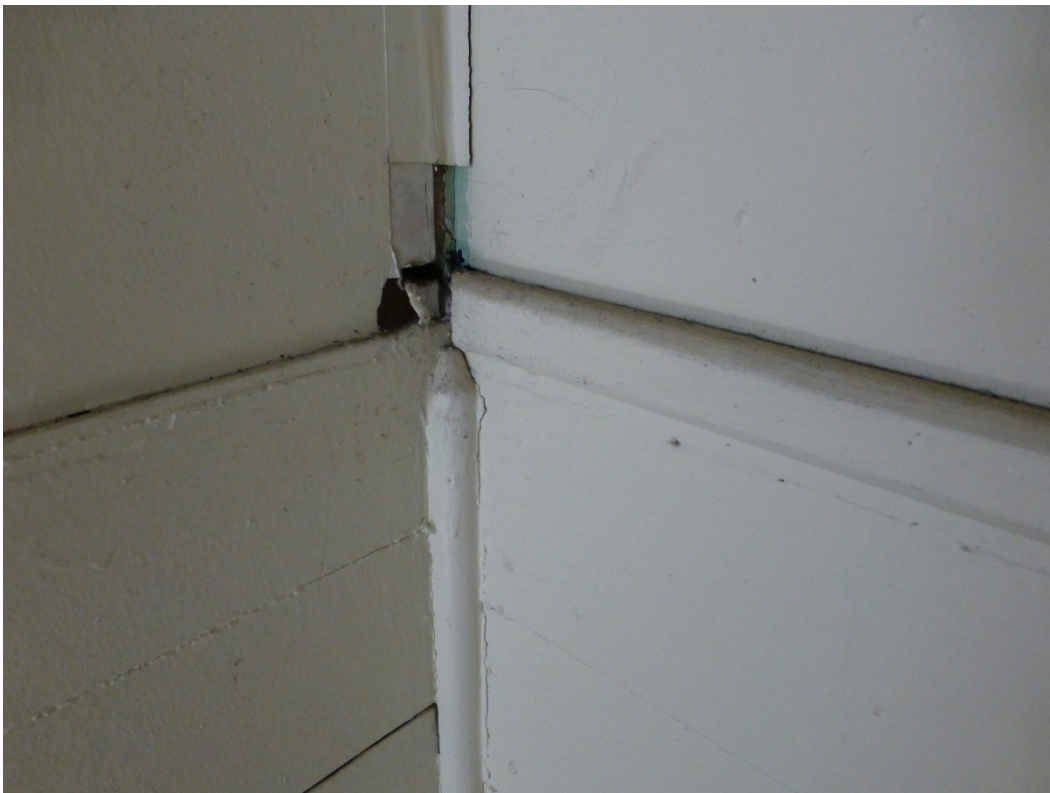
Figure 15. Original wood trim pieces in southeast hallway (ERDC-CERL, 2013).

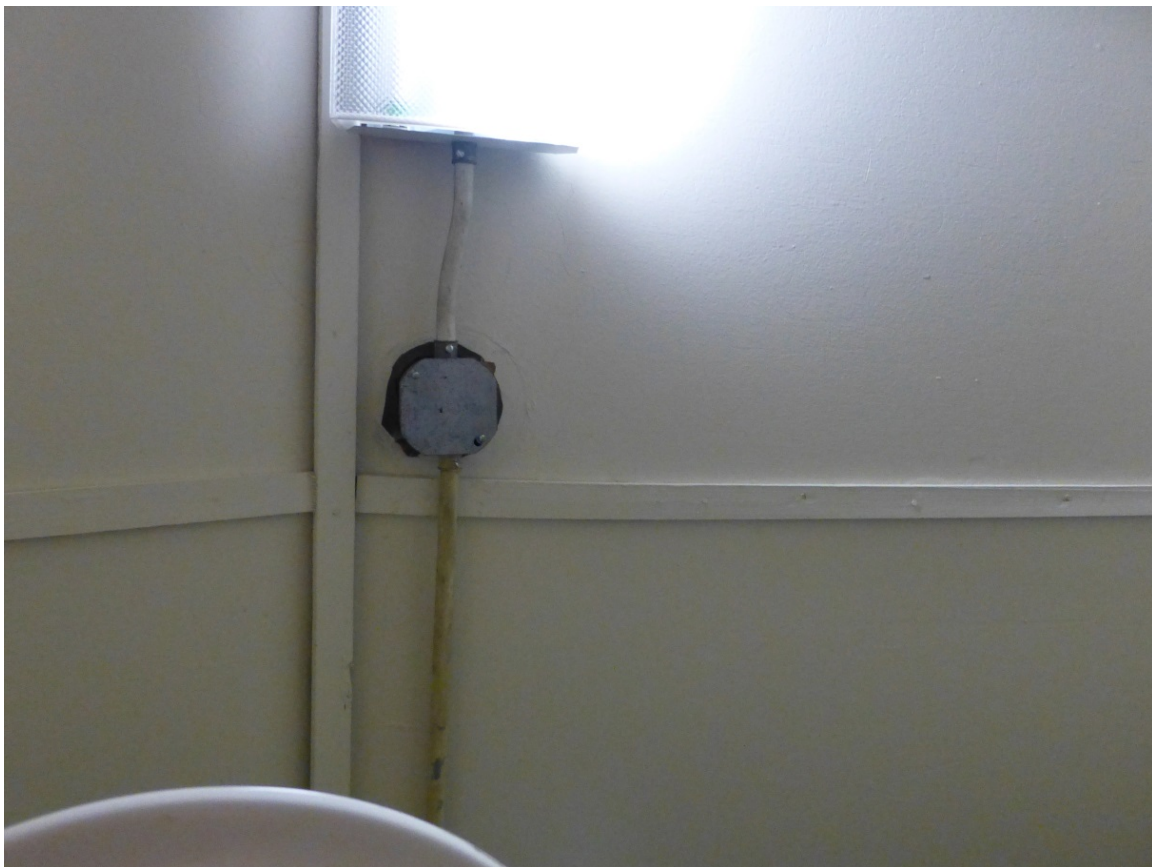
The original wallboard ceiling with wood trim pieces is extant throughout the building (e.g., Figure 16), except for the dropped ceiling in the shower room and restroom in the southeast portion of the building (Figure 17). The ceiling also contains the original room vents, and the trim for those vents is original as well (Figure 18). The building has original exposed structures that exist from the ceiling to the walls (Figure 19). The original wallboard, wood supports, and the ceiling vents are character-defining features.

Figure 16. Looking up to ceiling with original wallboard and original wood trim pieces (ERDC-CERL, 2013).

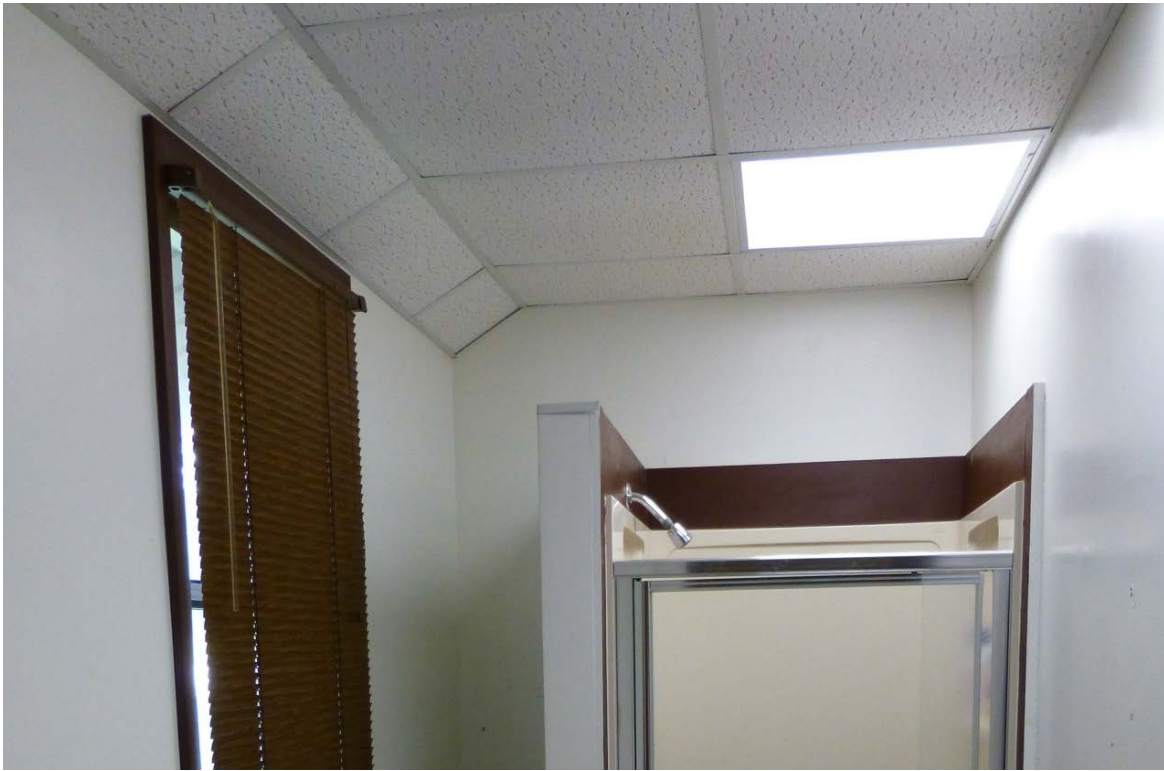
Figure 17. Non-original dropped ceiling in the shower room in the southeast shower room (originally an officers' toilet) of the building (ERDC-CERL, 2013).

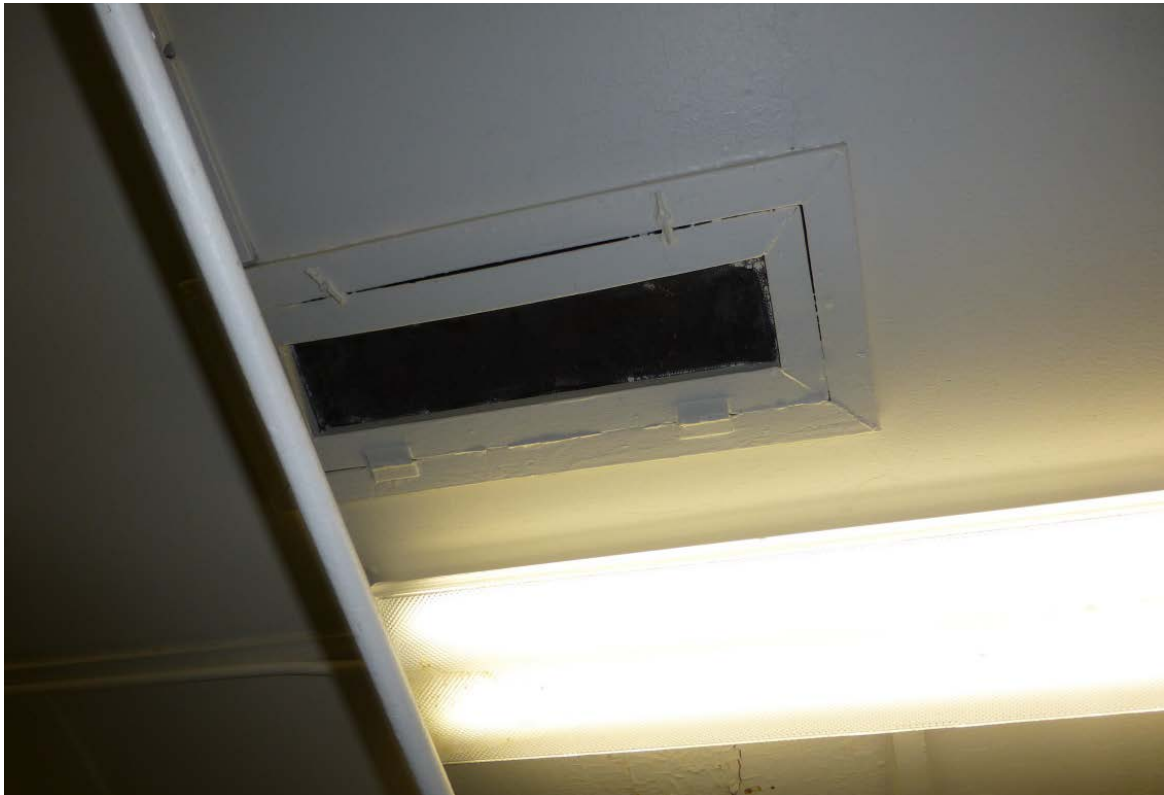
Figure 18. Original room vents on ceiling with original wood trim (ERDC-CERL, 2013).

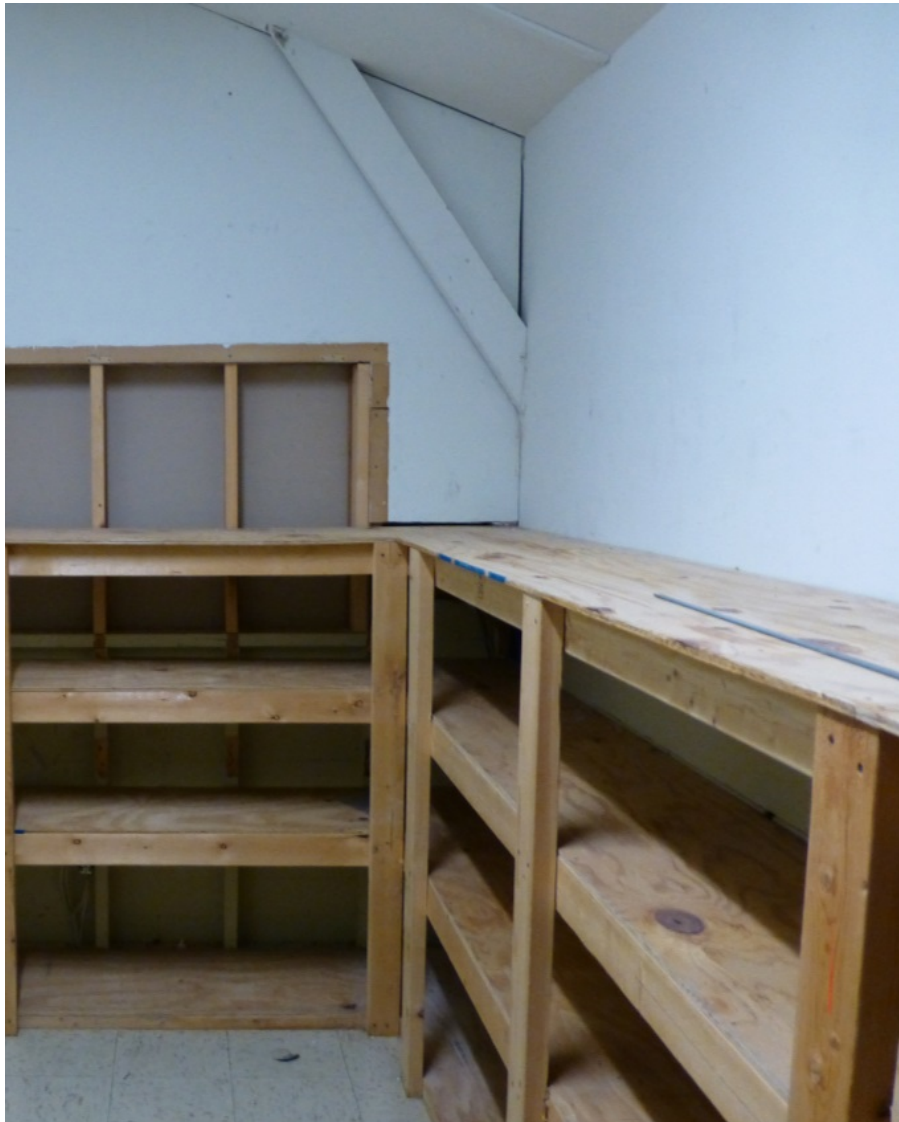
Figure 19. An example of an exposed structure (ERDC-CERL, 2013).

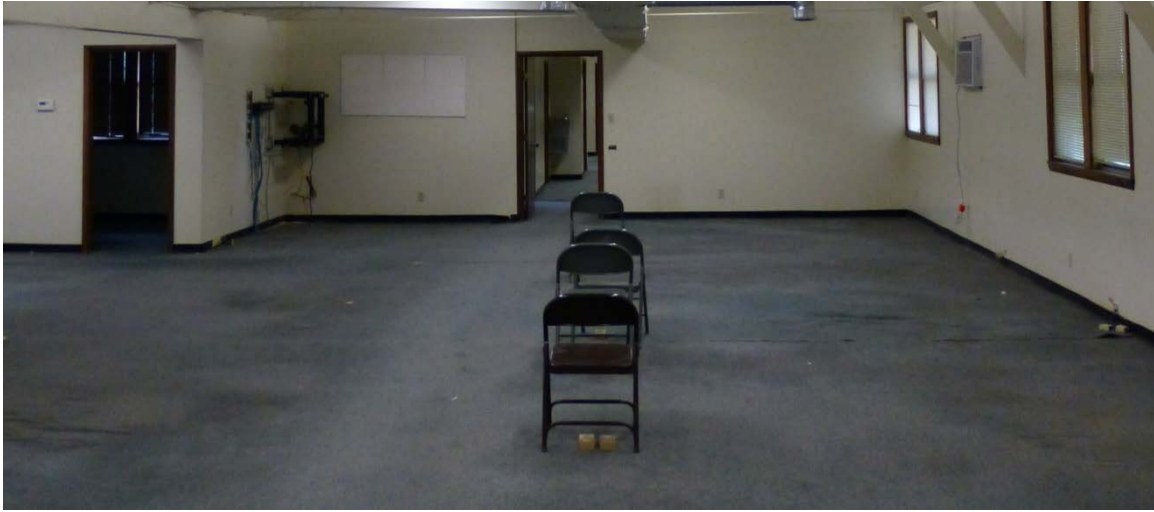
It is not known what is under the carpet in the main rooms or the vinyl tiles in the kitchen and restrooms. Neither the carpet nor the vinyl tiles are original to those areas (Figure 20 and Figure 21). Since the building's original use was administration, the original flooring would have been wood (as in Figure 22); however, it is not known if linoleum was installed over the wood floor when the building was converted to an officers' club.

Figure 20. Carpet covers the floors in the main rooms (ERDC-CERL, 2013).

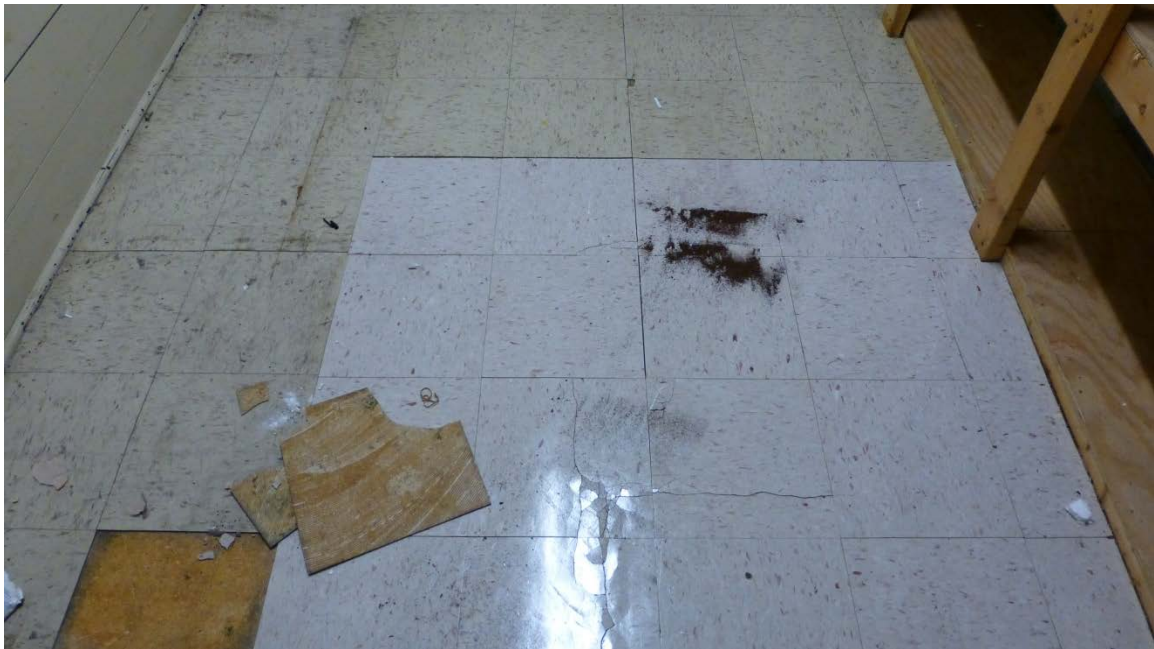
Figure 21. Example of vinyl tile that covers the floors in the kitchen, restrooms, and some minor rooms (ERDC-CERL, 2013).

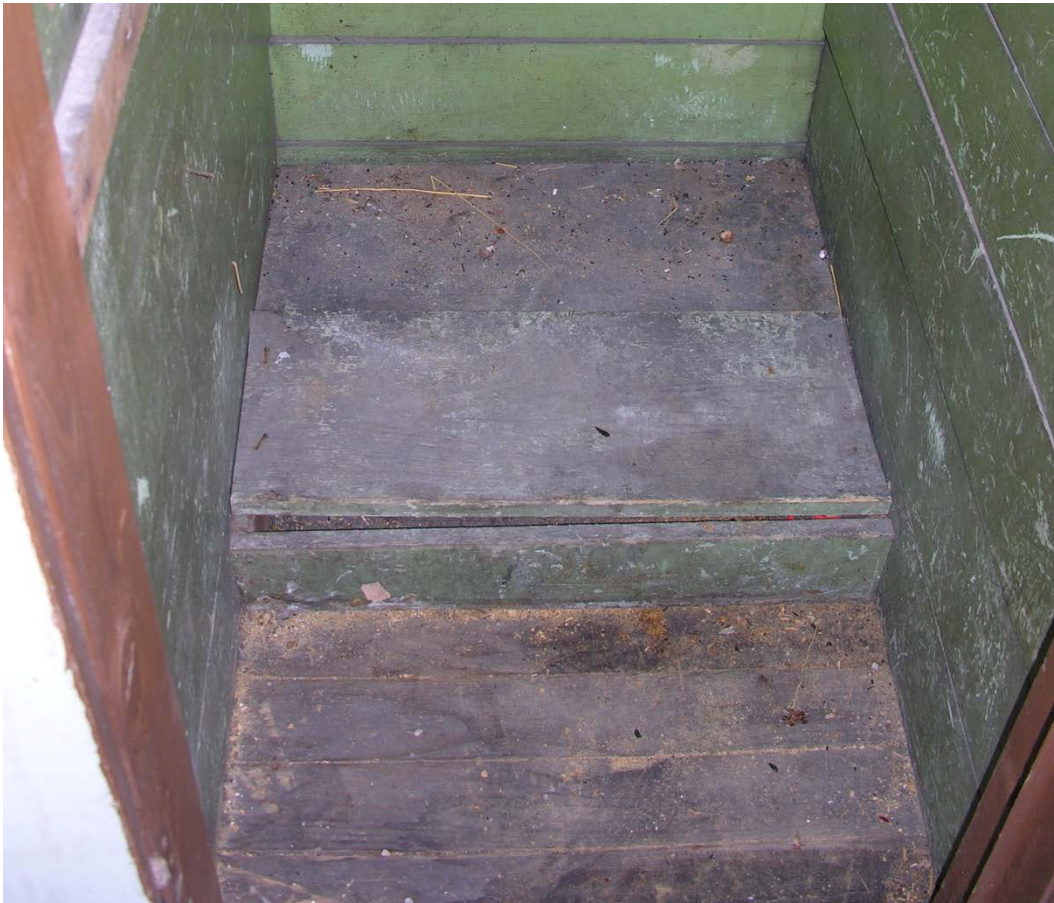
Figure 22. Original wood floor in the closet in the southeast side of the building (ERDC-CERL, 2013).

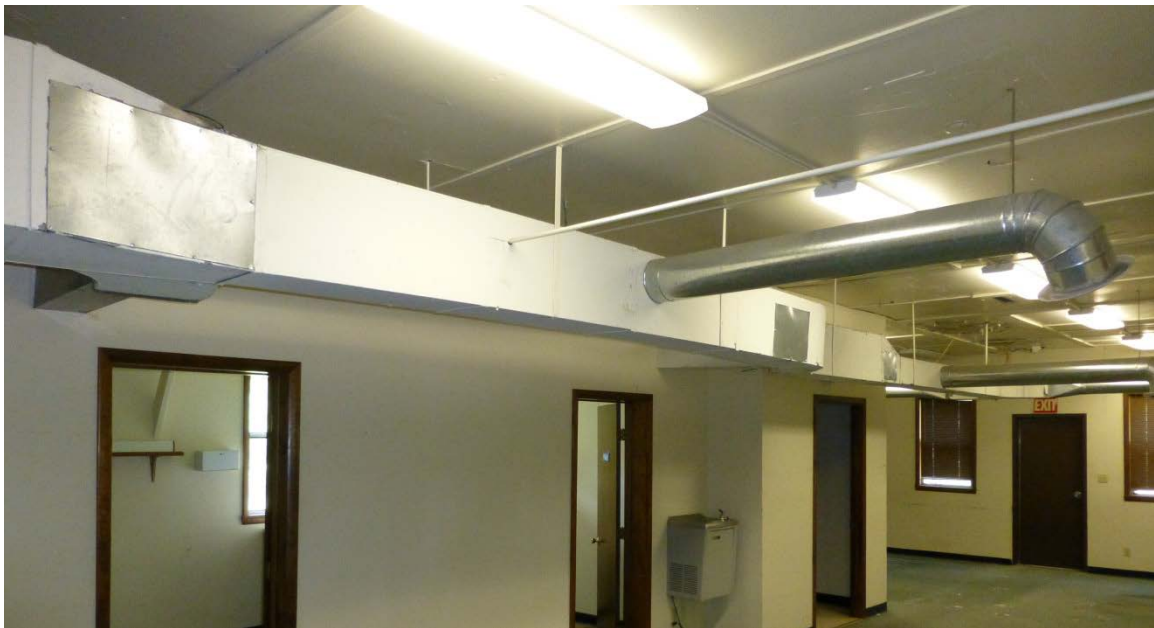
The main rectangular heating duct that runs the length of the building and the rectangular duct extension that runs into the ell are original to the building (Figure 23). These rectangular ducts are character-defining features of the building. However, the round ducts that branch off from the main duct line are not original (Figure 24).

Figure 23. Example of rectangular main duct (ERDC-CERL, 2013).

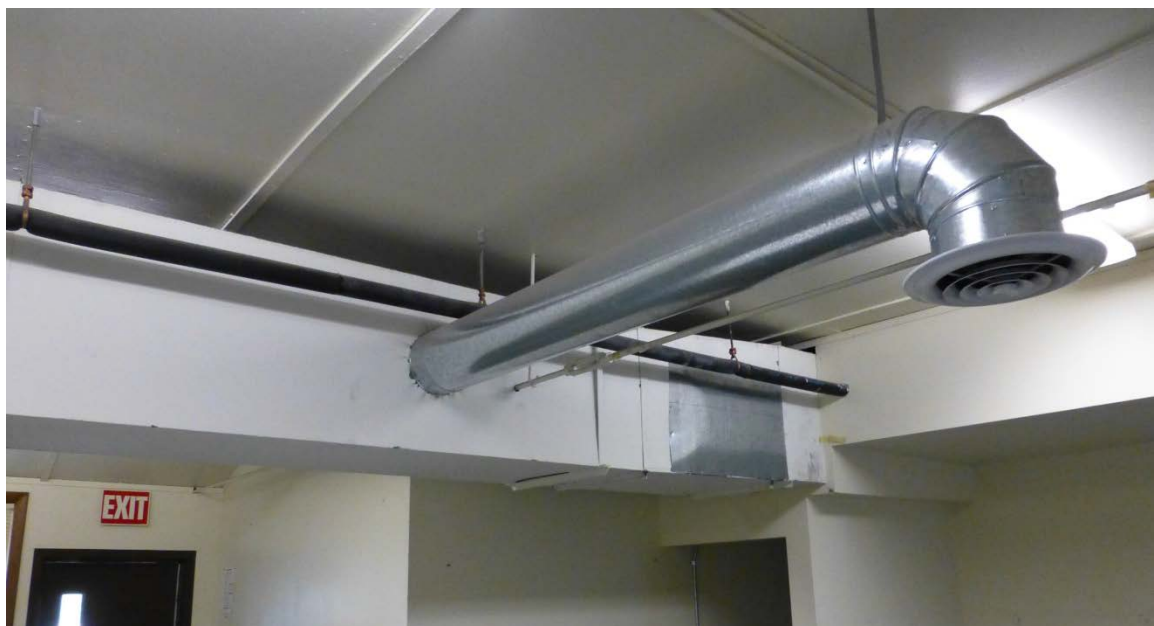
Figure 24. Non-original round ducts (ERDC-CERL, 2013).

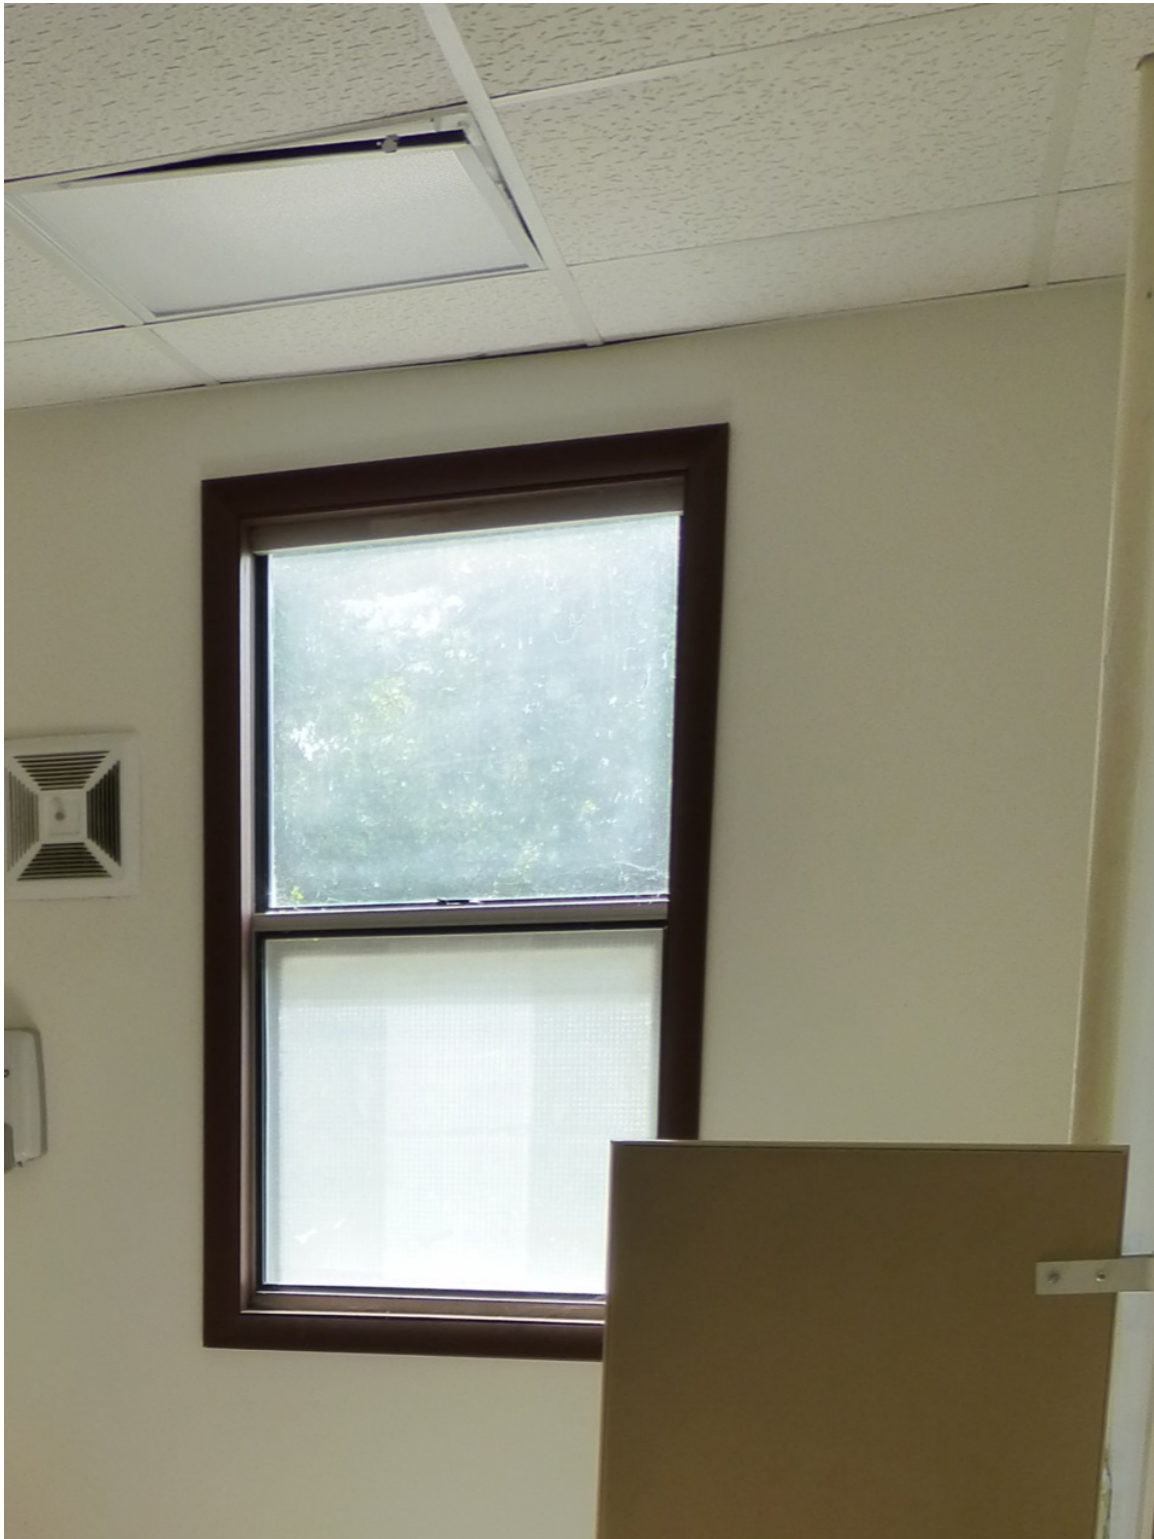
None of the windows are original (Figure 25).

Figure 25. Example of one of the non-historic windows (ERDC-CERL, 2013).

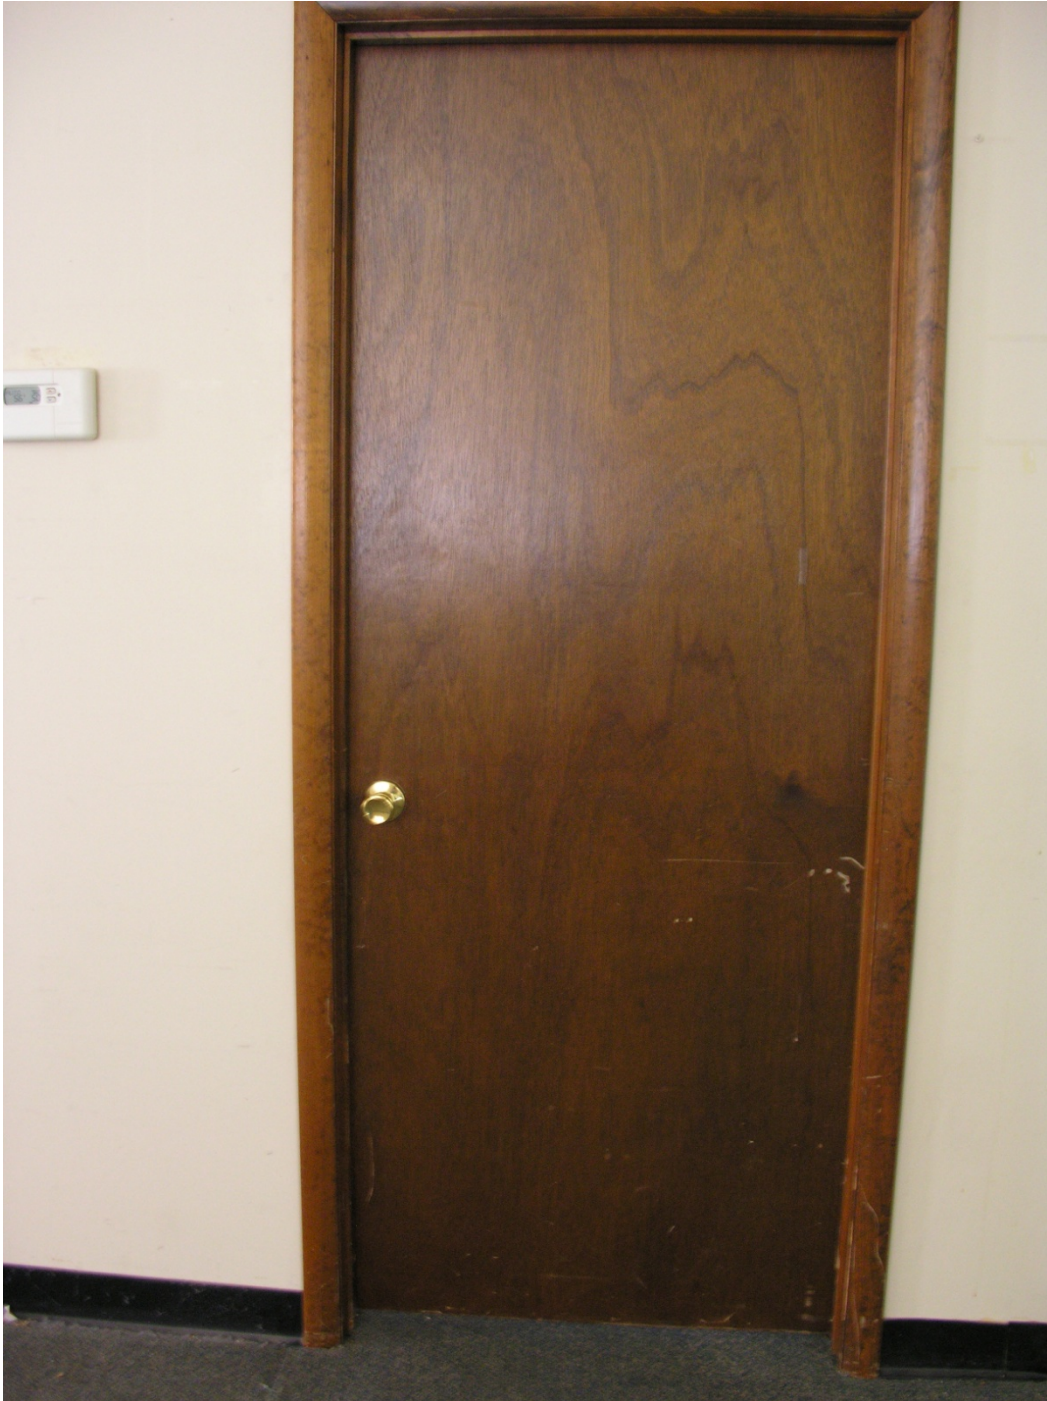
None of the interior doors are original (Figure 26).

Figure 26. Example of one of the non-historic doors (FLW, 2014).

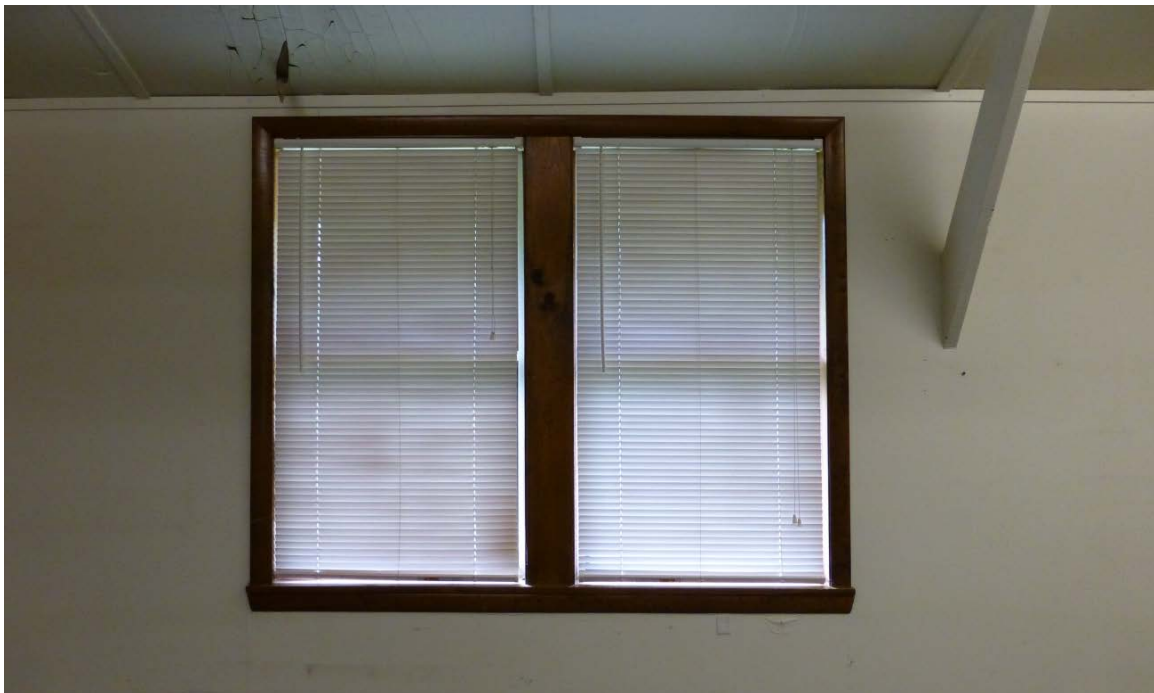
None of the trim (casing) that surrounds the windows and doors is original (Figure 27). The trim that surrounds the vent from the heater room is original (Figure 28). In addition, the trim on both sides of the fireplace and surrounding the mural is original (Figure 29). The trim that surrounds the ceiling vents, the heater room vent, and the fireplace is all character-defining. The trim that surrounds windows and doors is not character-defining.

Figure 27. Example of non-historic window trim (casing) surrounding a double window (ERDC-CERL, 2013).

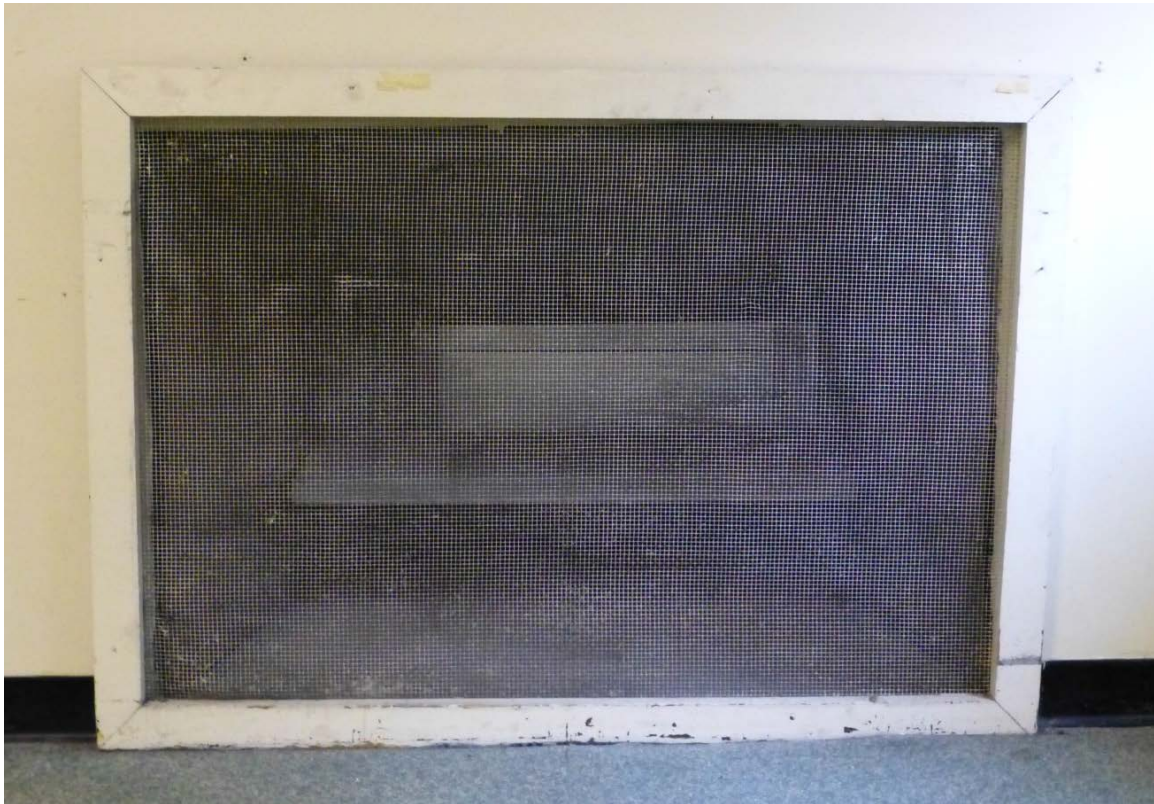
Figure 28. Original trim surrounding the air intake vent into the heater room
(ERDC-CERL, 2013).

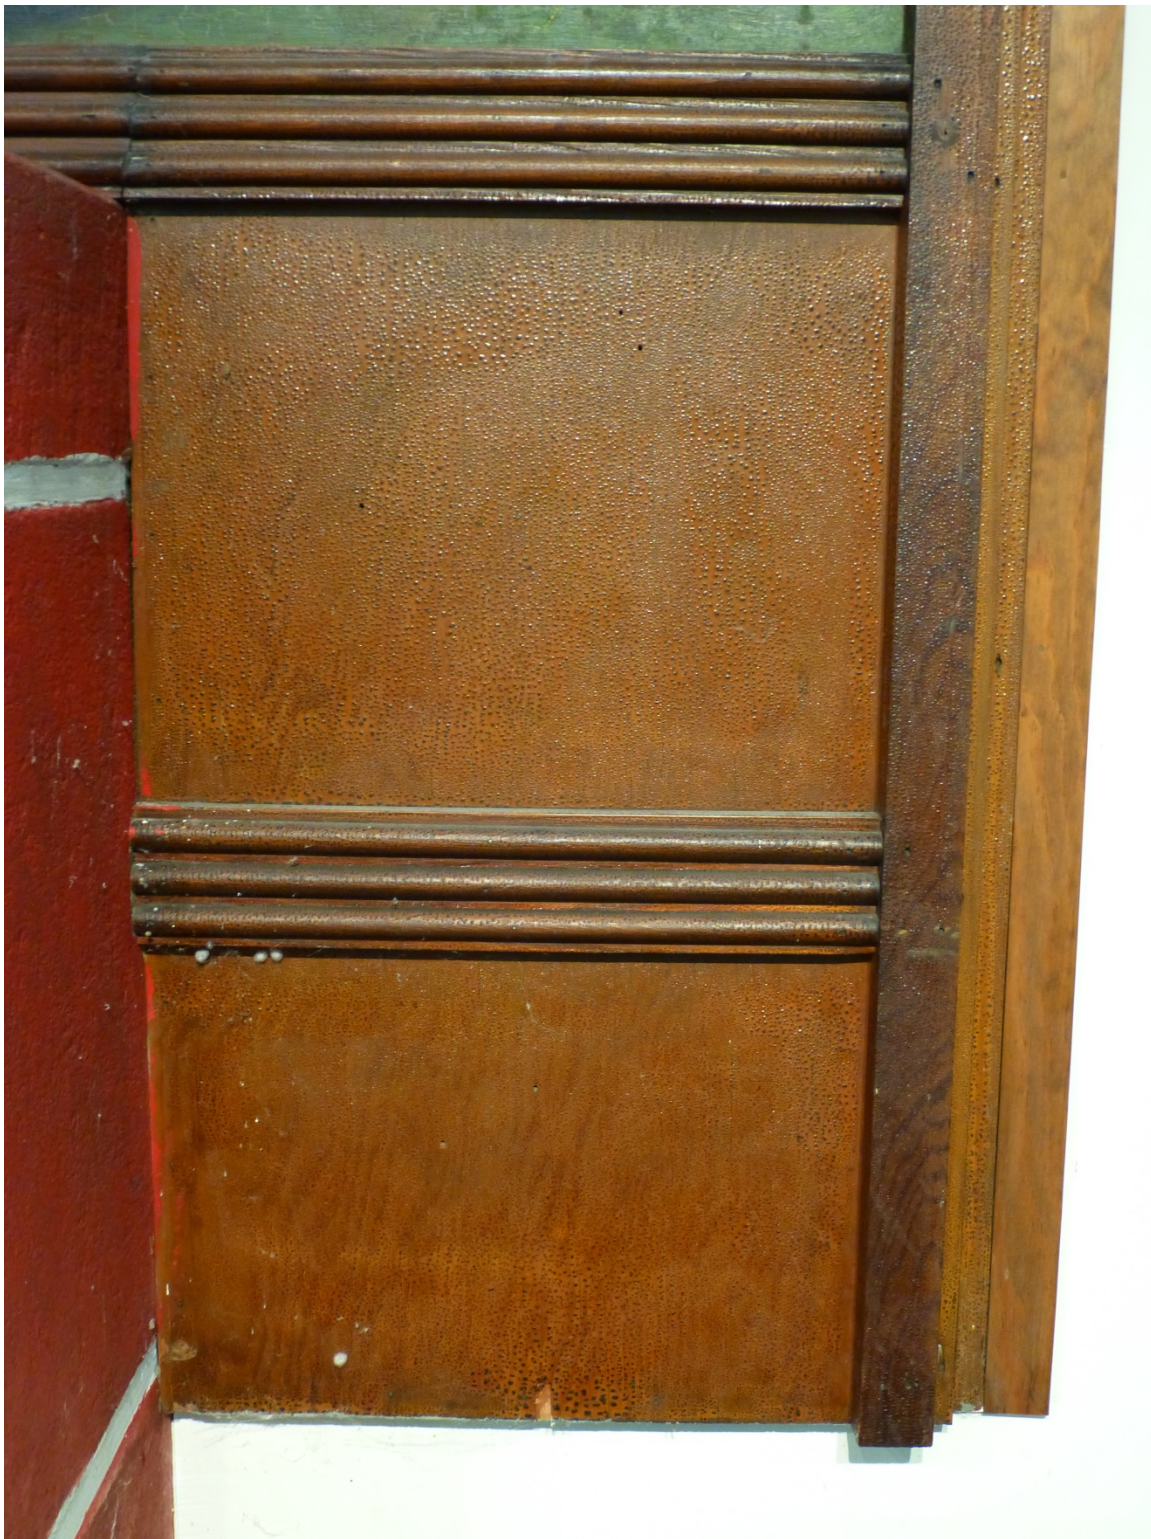
Figure 29. Original wood trim in close-up view to the right of the main-floor fireplace and below the mural (ERDC-CERL, 2013).
